THE CALIFORNIA EARTHQUAKE OF APRIL 18, 1906

STATE EARTHQUAKE INVESTIGATION COMMISSION

IN TWO VOLUMES AND ATLAS

ANDREW C. LAWSON, CHAIRMAN

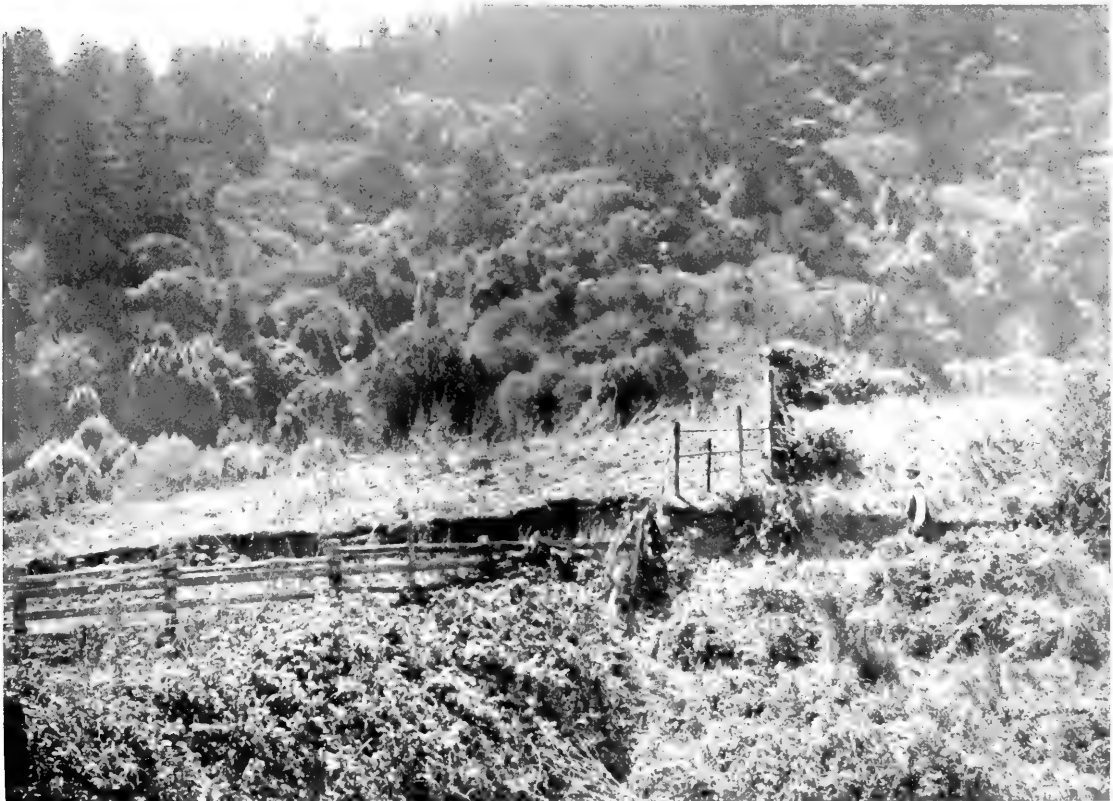
B. Fault-trace near Bondietti's ranch. Looking southwest. Shows vertical displacement bordering a sag. Horizontal displacement shown by fence, which had been repaired. G. K. G.

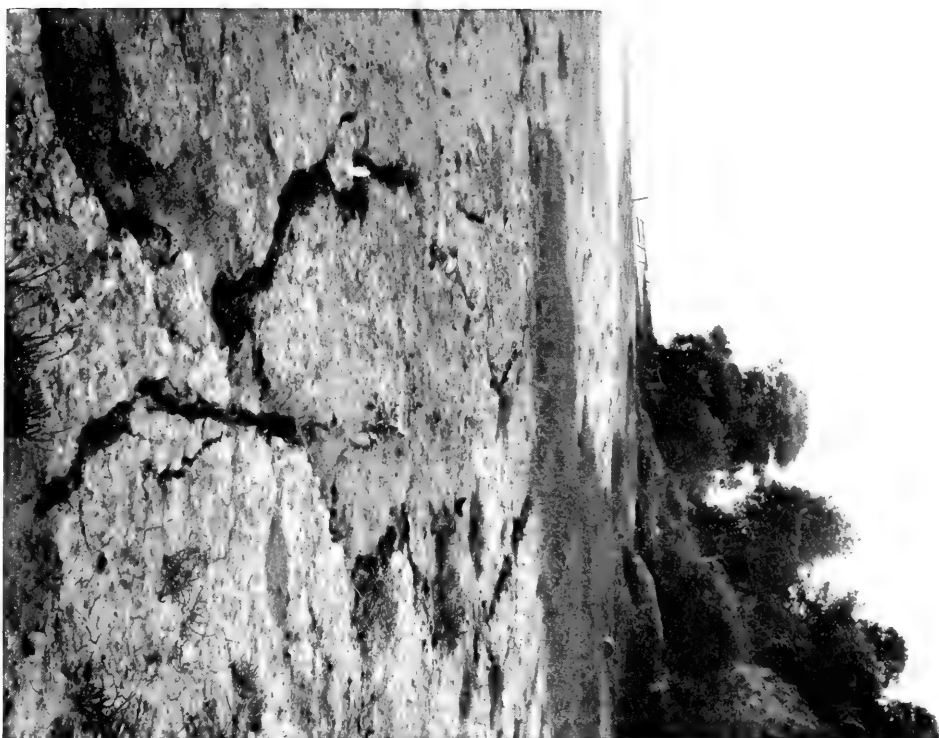
B. Cracks made by earthquake in tidal mud near head of Bolinas Lagoon. G. K. G.

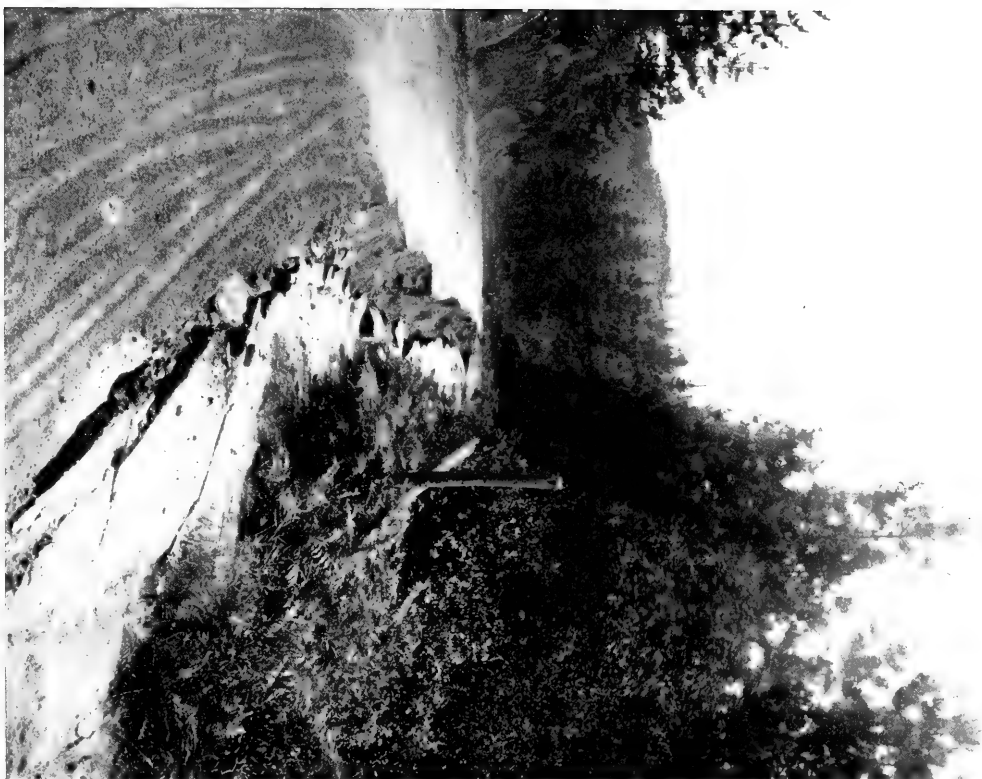
A. Roadside crack 2 miles west of fault, between Inverness and Point Reyes P. O. G. K. G.

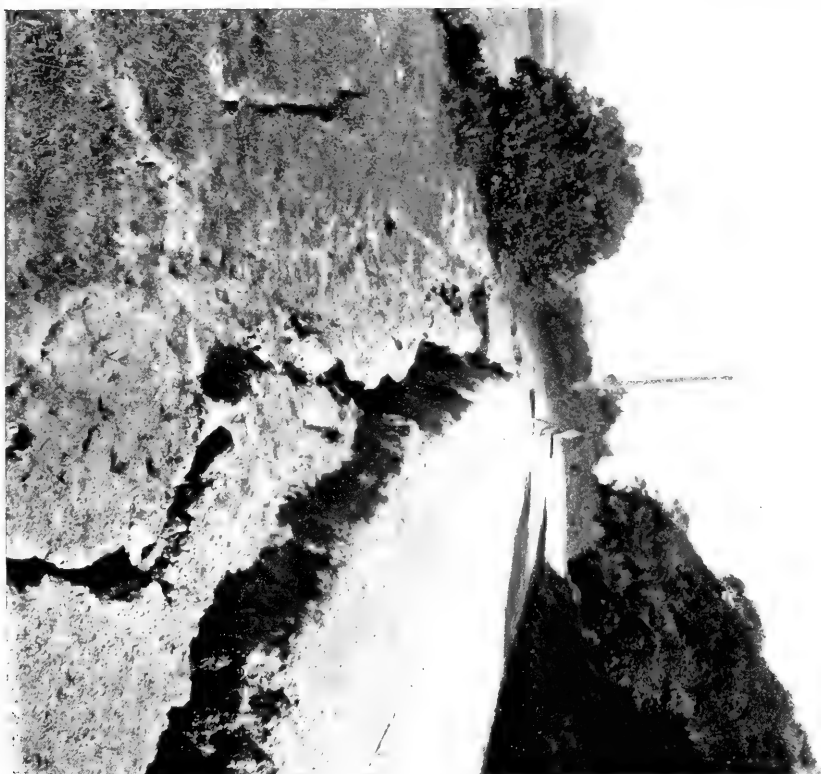
B. Roadside crack a mile southeast of Inverness. G. K. G.

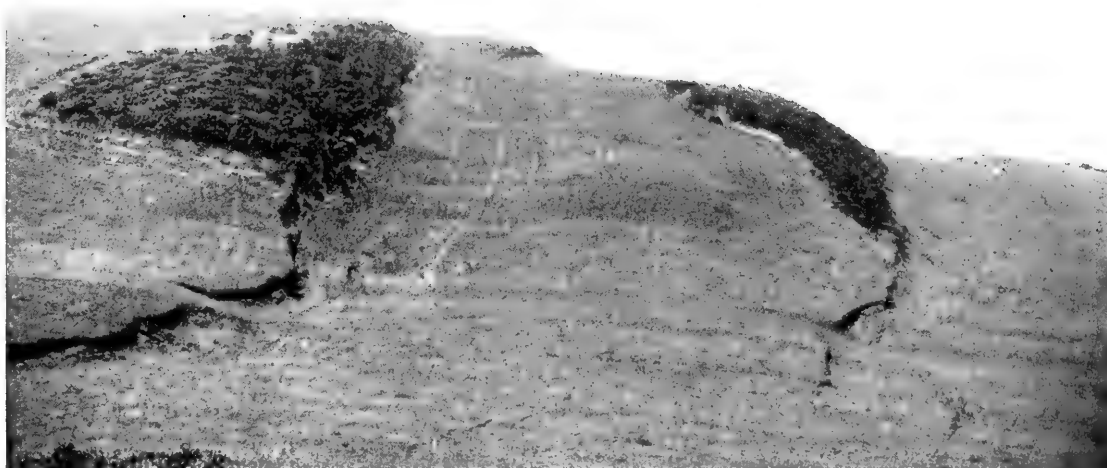
A. Group of earthquake cracks southwest of head of Pine Gulch Creek. Looking southwest. Structure well indicated by sky line. Since dislocation field has been plowed and farm road graded up fault-scarps. Compare Plate 53 A. G. K. G.

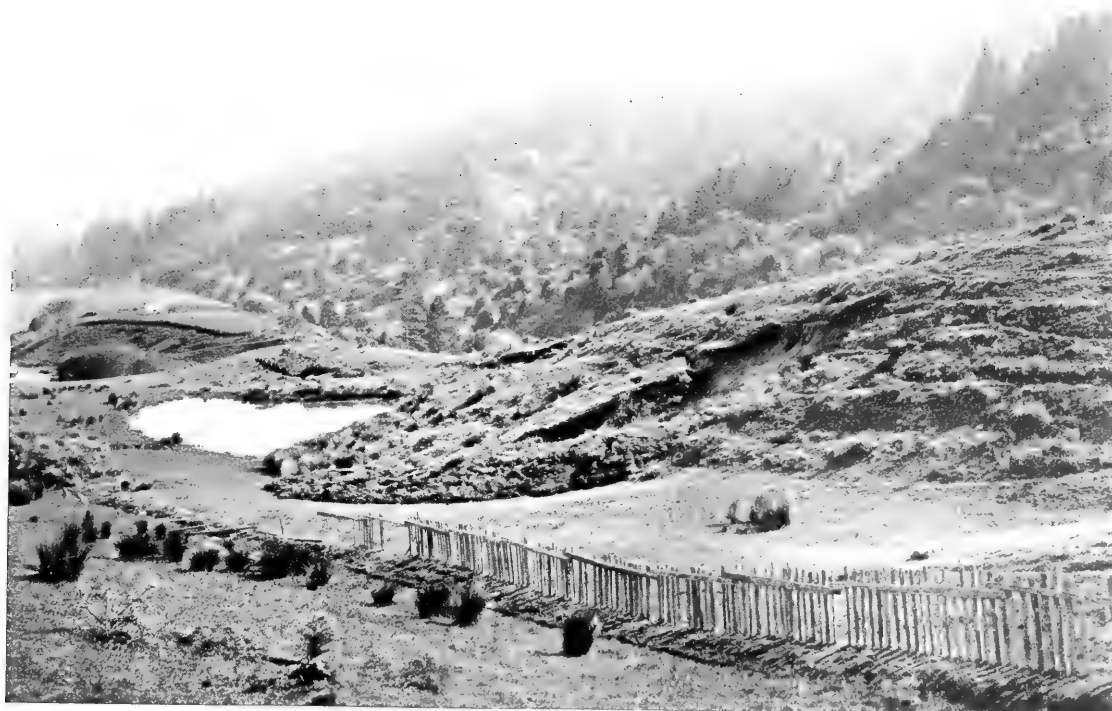
A. Landslide 4 miles northwest of Bolinas Lagoon. Looking south-southwest. Slide encroaches upon a rift pond, caused directly by rains early in 1907, indirectly by earthquake of 1906. G. K. G.

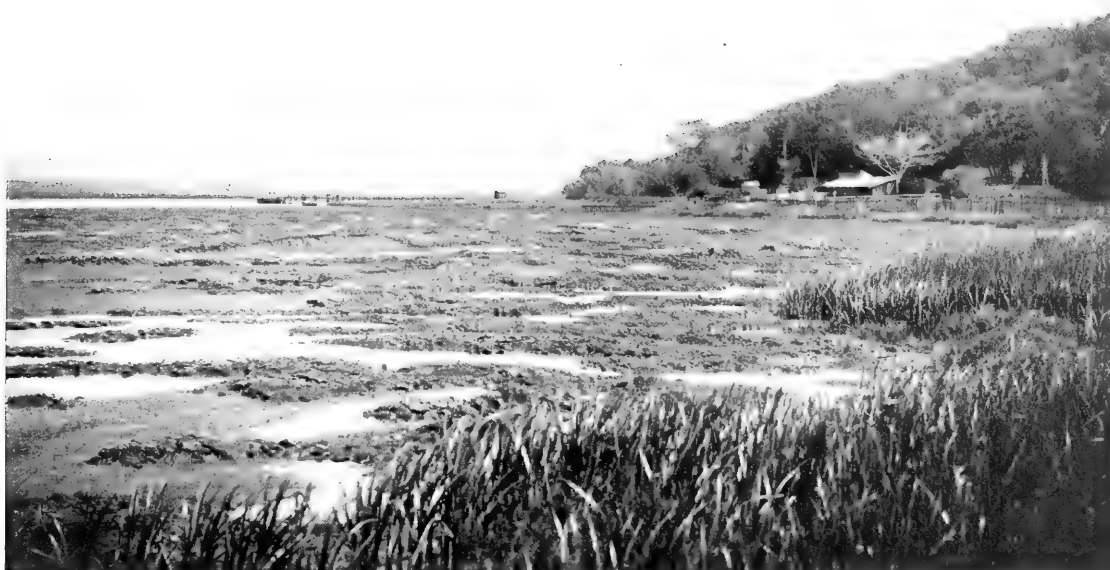
When the tidal mud was first seen after the earthquake, it was observed to be covered with ridges and troughs. (Plate 54B.) This corrugation was gradually smoothed out by the action of the waves (plates 55B and 56A), so that at the expiration of a year its expression was largely lost, tho a few of the larger ridges could still be traced, and much of the plain retained a pattern imprest on it by the ridging. It is probable that the entire tract of tidal mud was thus affected, altho the ridges were not seen on the area lying nearest to the east shore. That area did not come under observation until after the spring floods

B. Ridged mud plain 1 mile from Inverness. Looking east-southeast. Mr. Hamilton's barn at right. April 23, 1906. Tide is low. Pools occupy the deeper troughs. G. K. G.

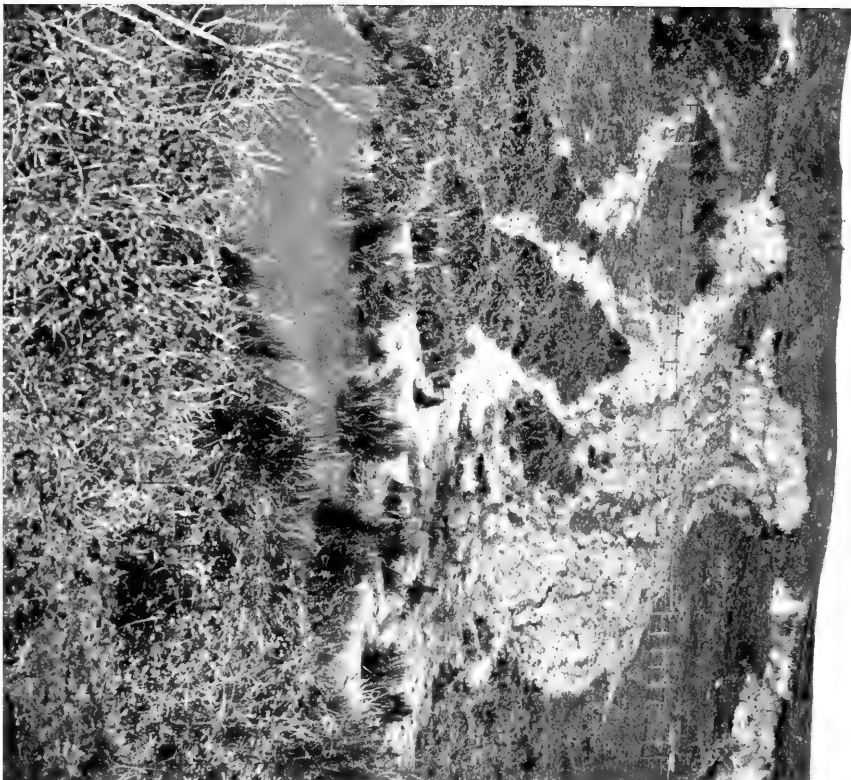
A. Landslides 2.5 miles northwest of Bolinas Lagoon. Looking northeast. Storm waters of 1907, guided by earthquake cracks, converted earth into soft mud. G. K. G.

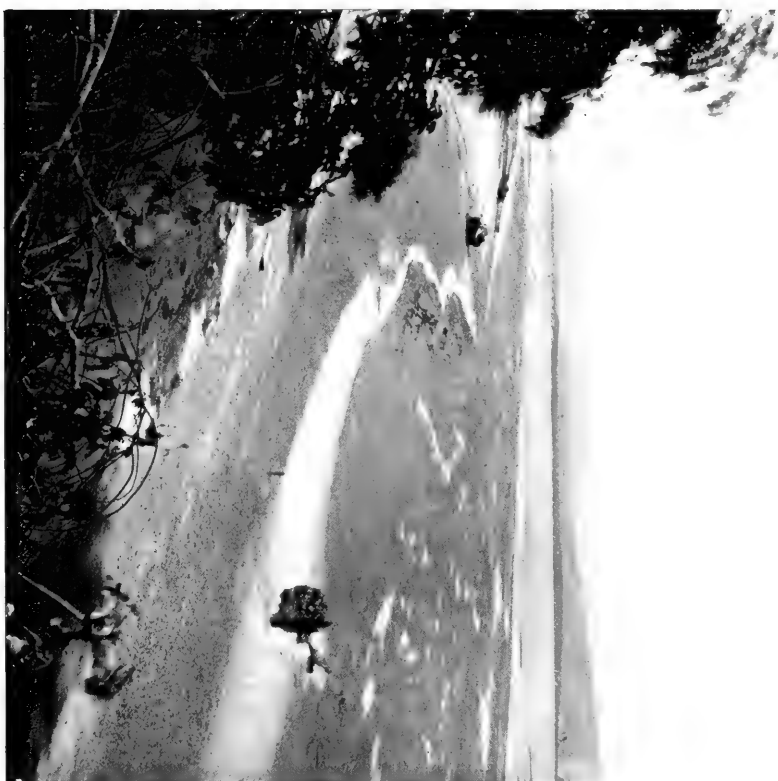
B. South part of Inverness shoal, at low tide, April 28, 1906. Looking north-northwest. Lane of water separates firm, gravelly beach from mud shifted shoreward by earthquake. G. K. G.

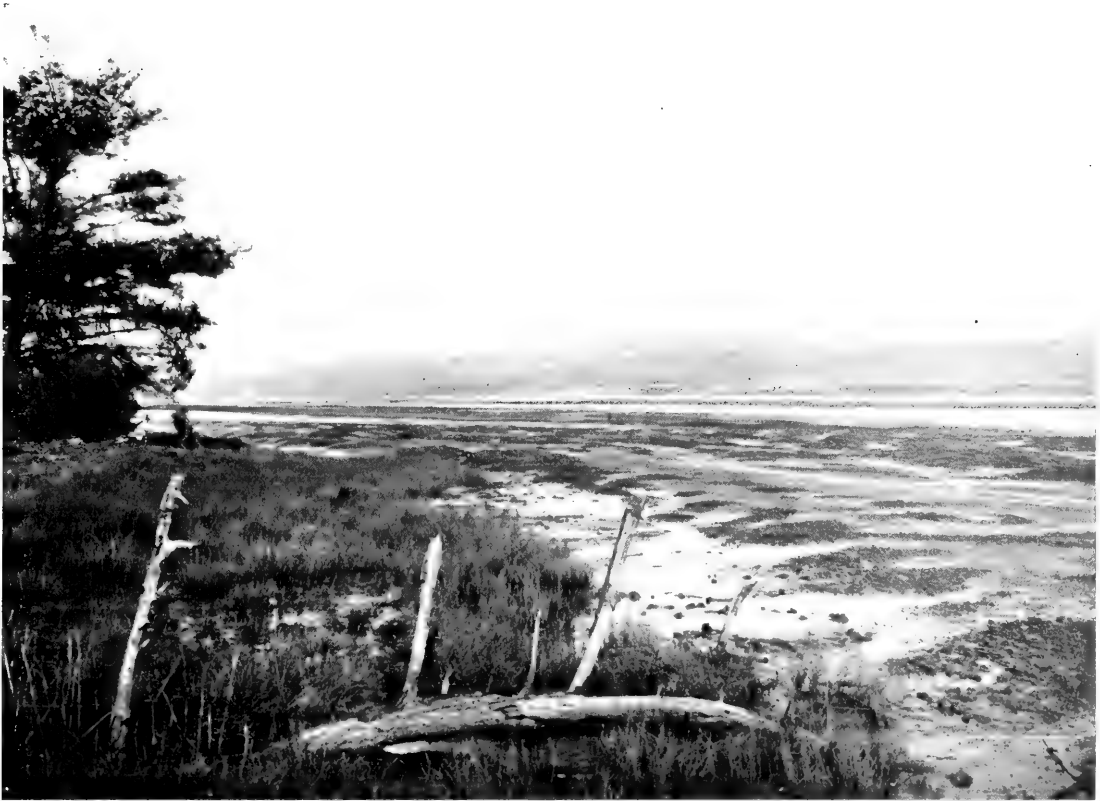
A. Ridges caused by earthquake on tidal flat of Tomales Bay, 1 mile south of Inverness. Looking north. December, 1906. G. K. G.

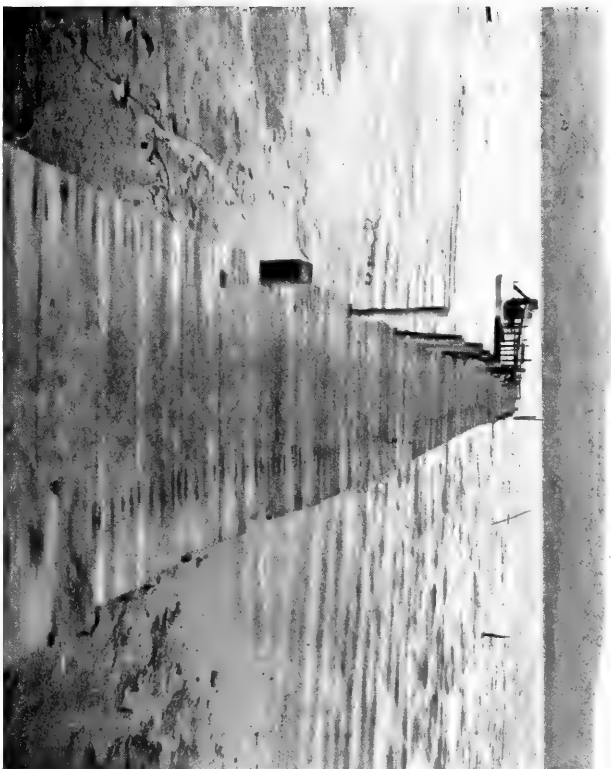
A. Martinielli's pier at Inverness. Originally straight; shifted and broken by earthquake. Repaired before photograph was taken. G. K. G.

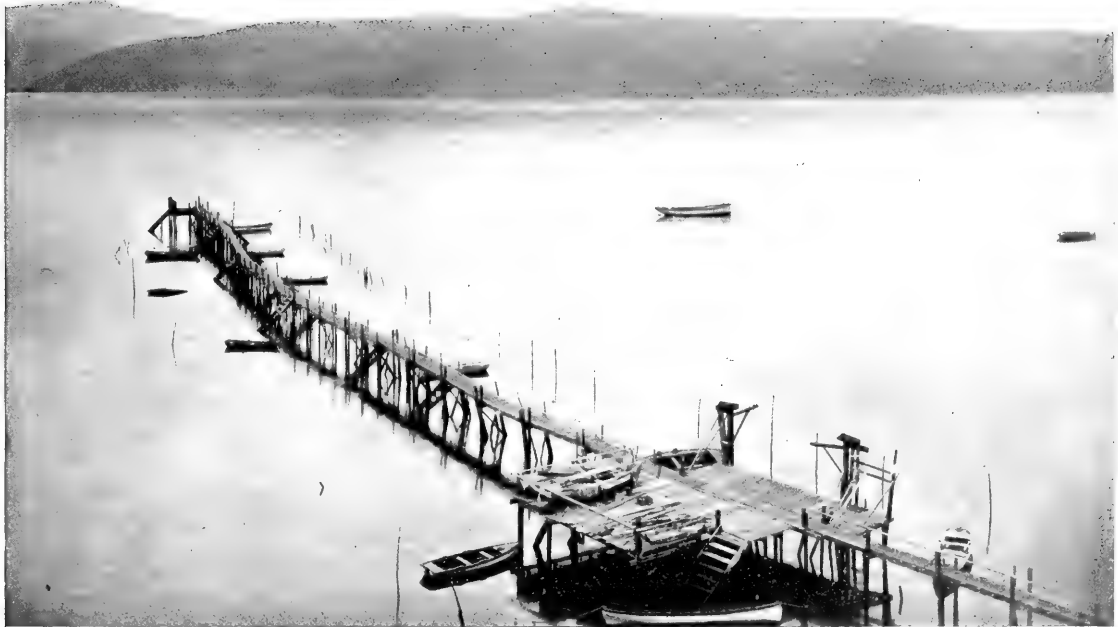
A. Bailey's pier at Inverness. Another view, position of camera being approximately same as in making photograph below, taken before the earthquake. G. K. G.

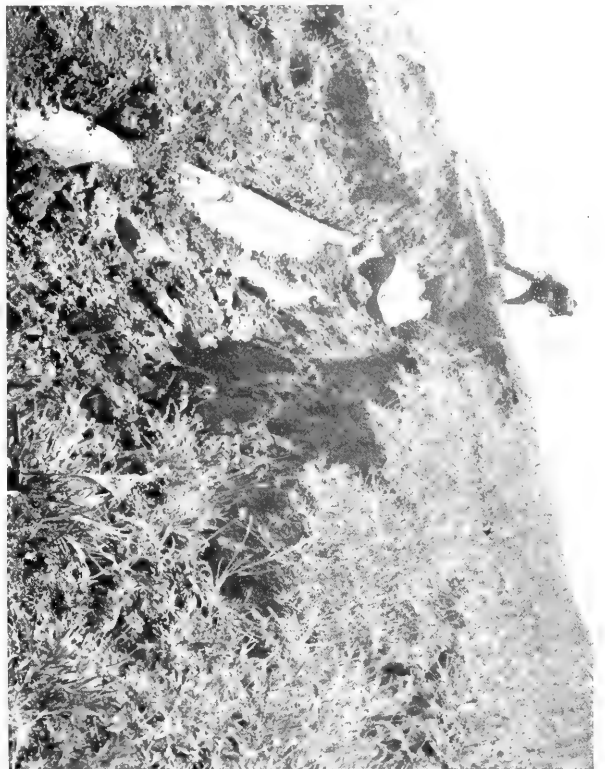
About 2 miles from the upper end of San Andreas Lake the fault encounters the 30-inch, laminated, wrought-iron pipe of the Spring Valley Water Company, which prior to the earthquake conveyed the water from Pilarcitos Lake to San Francisco. The metal of the pipe is about 0.1875 inch thick and coated with asphaltum. The pipe is buried in the soil at a depth of 3 to 4 feet. The point of intersection is near Small Frawley Canyon. Here the course of the pipe swings from a northwesterly to a more northerly course, and the fault consequently intersects it at an acute angle. At the point of intersection, the pipe was obliquely sheared apart and telescoped upon itself, effecting a shortening of about 6 feet. The amount of the transverse offset involved in the shear was about half the diameter of the pipe. The portion north of the break was moved east and telescoped southerly. For 0.875 mile southeast of this point, the path of the fault lay on the northeast side of the pipe and nearly parallel to it, but a short distance away. About 220 yards southeast of the intersection, where the pipe, buried a few feet below the surface, ascends a rising slope, the pipe had completely collapsed for a distance of several

yards, due doubtless to the establishment of a partial vacuum within the pipe by the sudden withdrawal of the water from the arch in the pipe at the time of the shock, owing either to the leakage below, or the propulsion of the water induced by the shock. (See plate 60B.)

F. Collapse of 30-inch water-pipe northwest of San Andreas Lake. F. L. H.

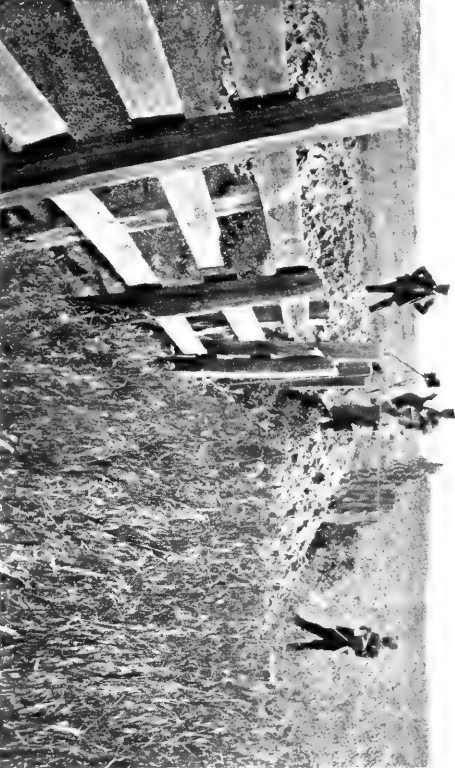
furrow. The movement was in the same direction as before, therefore a pulling apart of the pipe took place instead of a compression. There occurred two breaks in the pipe (see plate 59A), the main one at the crossing of the fault, and the other 150 yards away on the northeast side of the fault, but very near it, the pipe being almost parallel with it. At the main break, the pipe was pulled apart 59 inches, and at the other one 21.5 inches, making a total displacement of 6.666 feet. The pipe was not quite parallel with the fault and therefore there was a slight offset, at right angles to its direction, of 4 inches at the main break and 2 inches at the minor one, or a total of 6 inches. A fence which crost the fault at the main break is offset 6.5 feet. (Plate 60c.)

C. Offset of 6.5 feet in fence, northwest of San Andreas Lake. R. L. H.

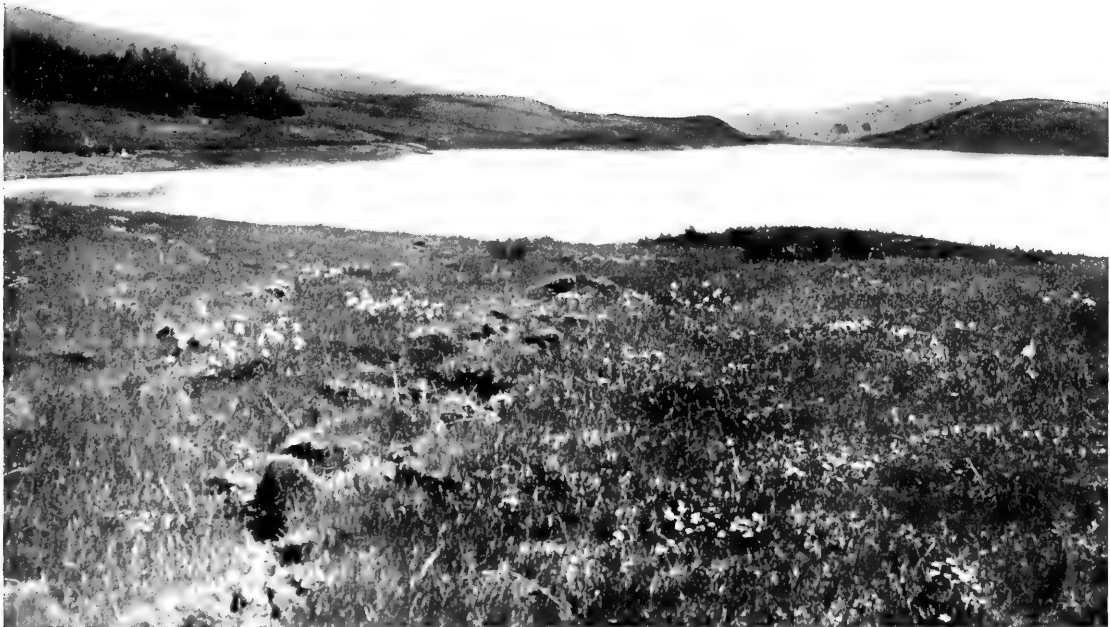
lake for the first 0.875 of a mile of its length. It then enters the water (plate 61D) and follows the northeast side of the lake, a little distance from shore, to the San Andreas dam at the lower end of the lake. In this distance of nearly 2 miles, the fault-trace emerges from the water at a number of points where little capes project into the lake. The crossing of these capes by the fault-trace indicates that it follows a very straight course beneath the water of the lake. On the last of these promontories traversed by the fault, the main fault-trace has associated with it a number of auxiliary cracks. Between the main fault-trace and one of the diverging cracks, on the southwest side of the fault, is a brick and cement gate-well in connection with the tunnel which takes the waters from the lake toward Millbrae. This gate-well was circular in cross-section, the inside diameter being about 26 feet. The nearest point of the structure to the main fault-trace is within 5 feet.

A. Fault-trace where it passes into San Andreas Lake. D.

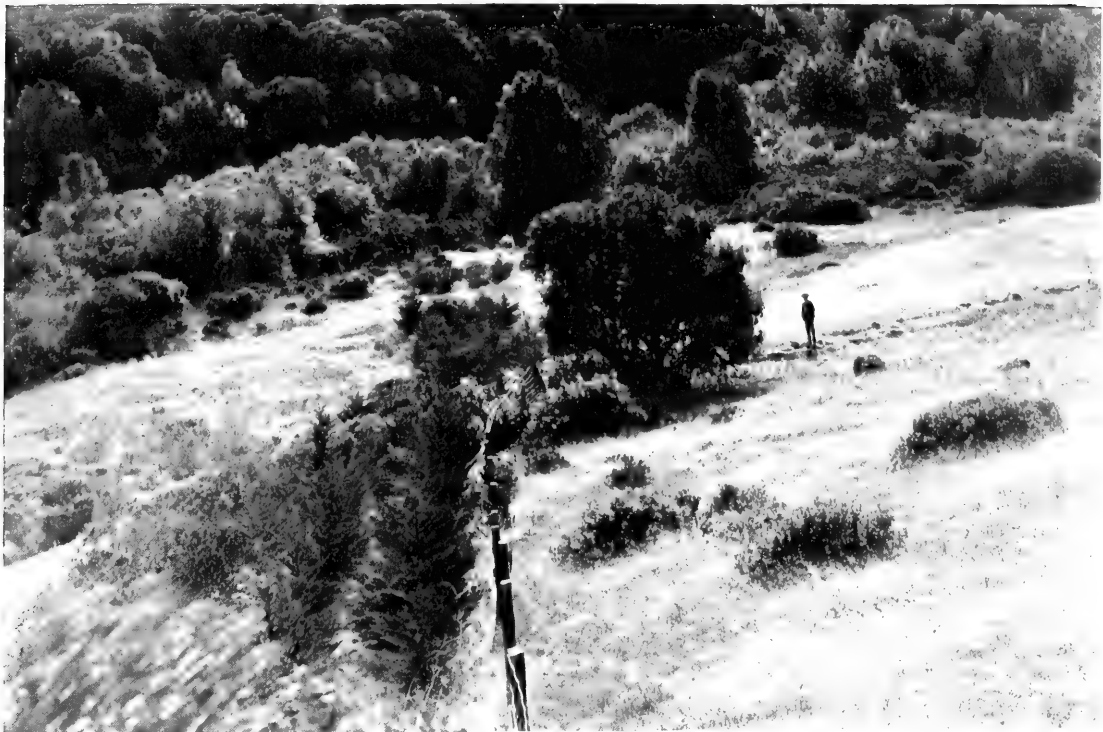
B. Offset fence near Crystal Springs Lake. R. A.

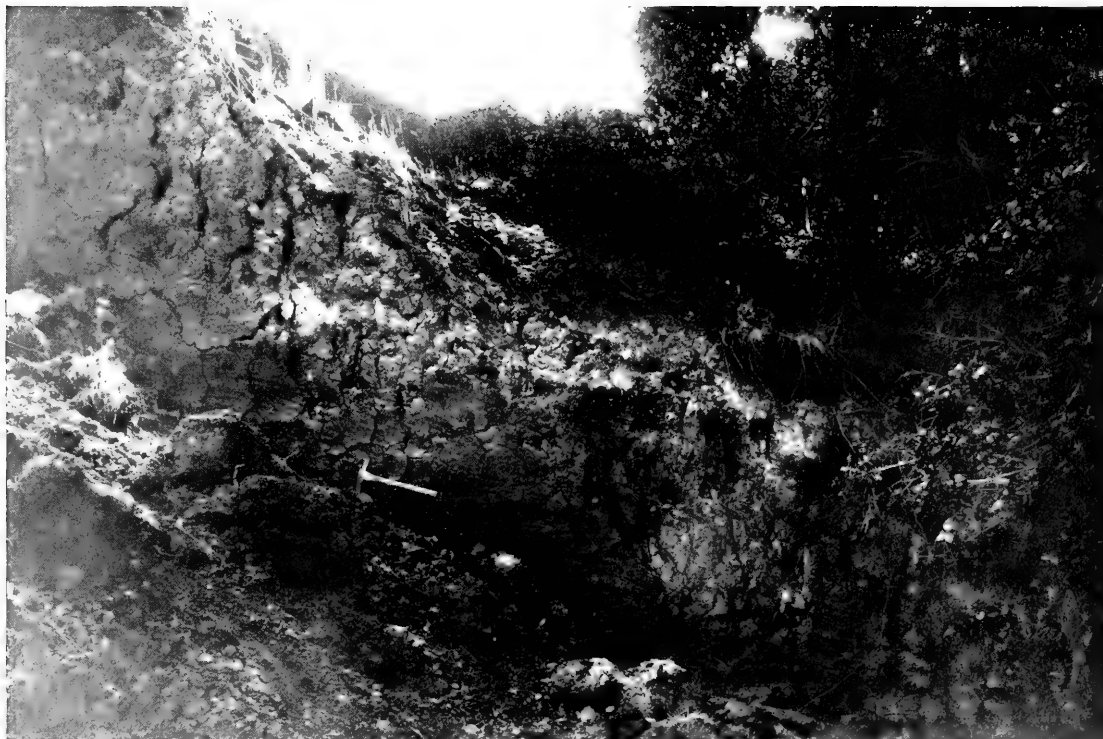
A. Exposure of slicken-sided fault plane near north end of Crystal Springs Lake. R. A.

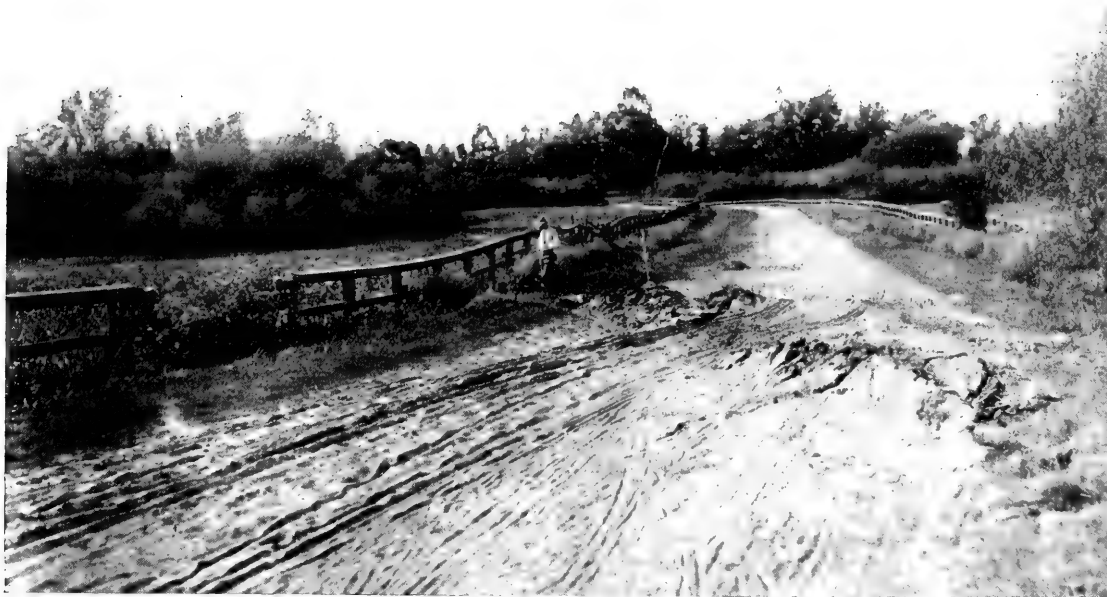
B. Offset of road by main fault near Searsville reservoir. Per J. C. B.

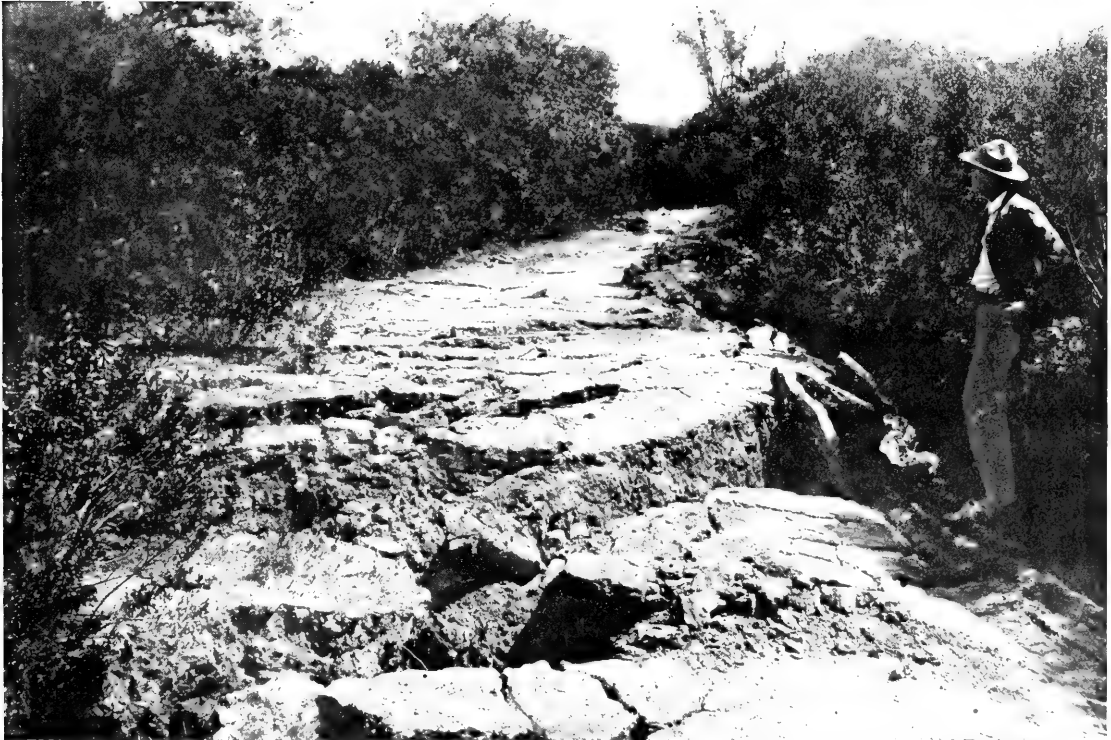
A. Offset of Alpine road 5 miles west of Stanford University. Per J. C. B.

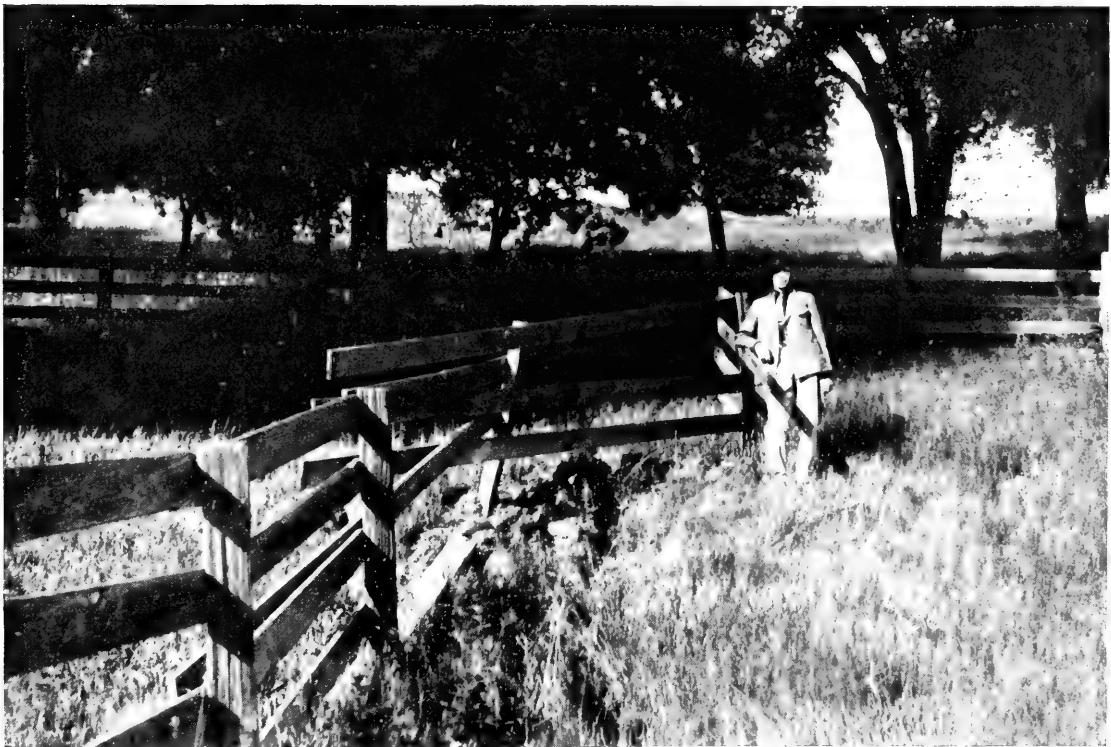
B. Offset of 8 feet in fence on Folger ranch, near Woodville. Per J. C. B.

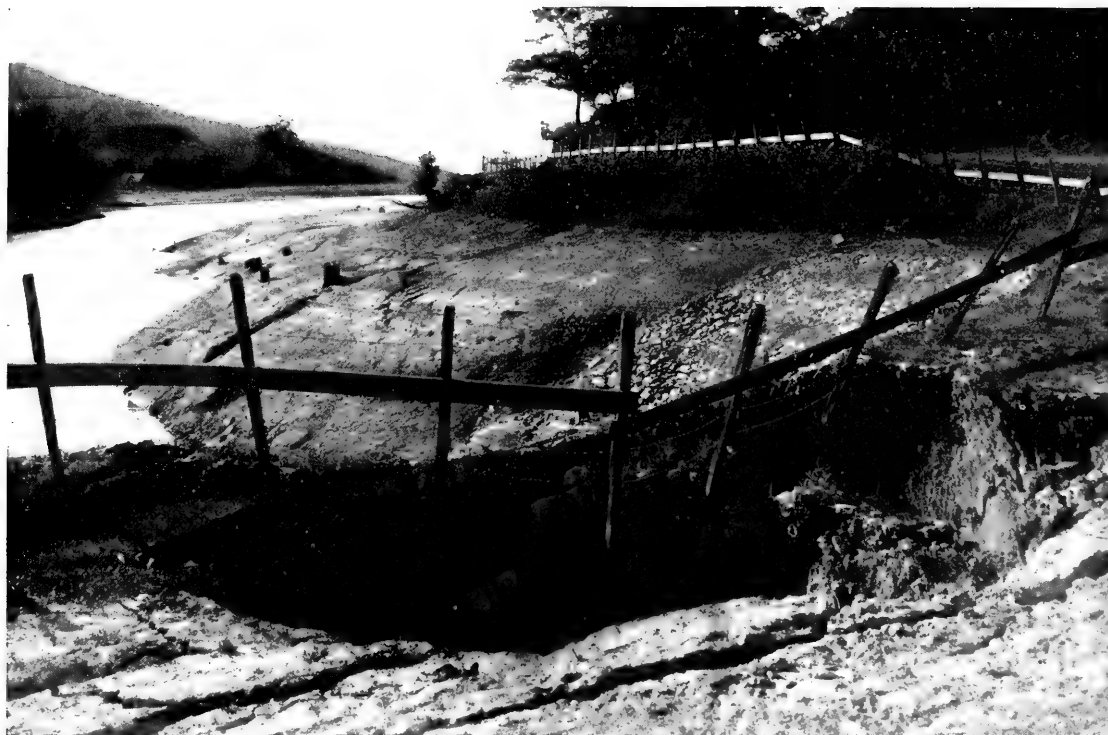
South of Congress Springs. — Near and northwest of the reservoir 2.5 miles southeast of Congress Springs, fissures from 4 to 6 feet wide ran nearly north and south, and past thru the earthen dam at the northwest end of the reservoir. (Plate 64A.) The intake pipes at the south end of the reservoir were disconnected, and the escaping water undermined a part of the southern dam of the reservoir. This reservoir is in a topographic saddle and has dams at both ends. The fault-trace passes thru this saddle. Where the bottom of the reservoir was exposed by the escape of the water, cracks of the fault-trace were exposed in the mud. Fences crossing the fissures showed but little displacement; the displacement moved the northeast side toward the southeast, relatively. The hills southeast of the reservoir have steep slopes of from 20 to 50 degrees. The cracks follow the east-facing slopes and the east side of these cracks had raised about 6 or 8 inches. Southeast of the reservoir the chimneys and water-tanks were down.

A. Reservoir in saddle south of Saratoga traversed by main fault. D.

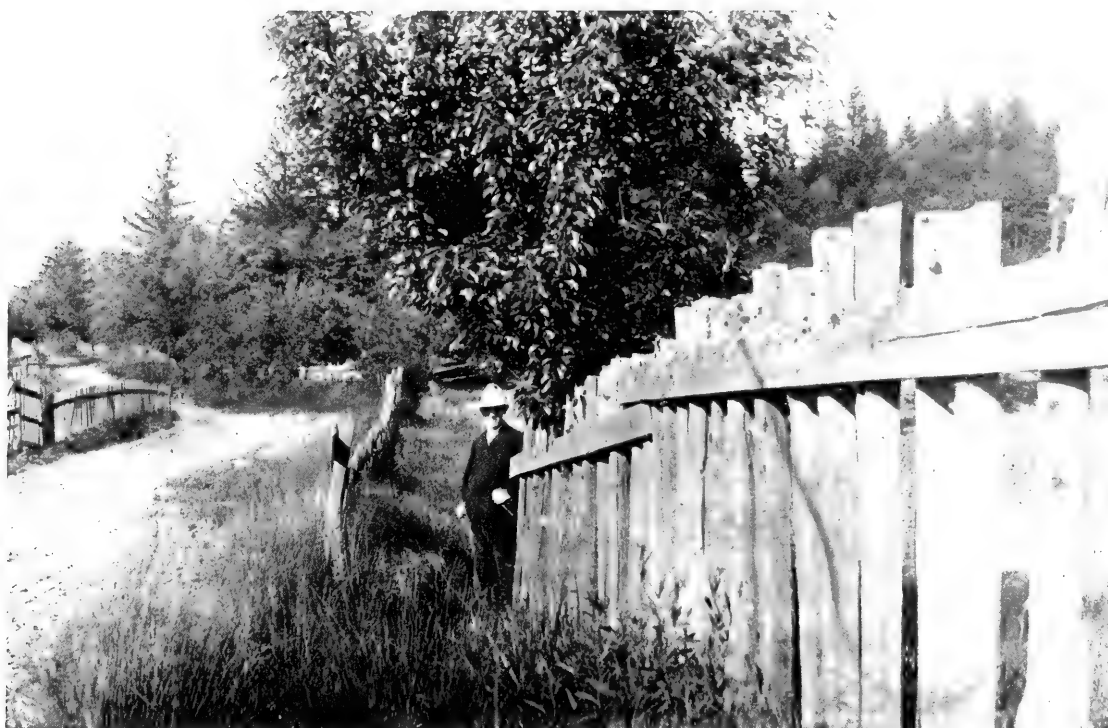
cracks alternating with a few long, continuous fissures, mark the course from Patchin to Wright Station. Thru the Morrell ranch it is especially evident. (See plate 64B.) At Wright Station the movement is well shown in the railway tunnel. (Fig. 42.) This tunnel runs southwest, and about 400 feet in from the eastern end of it there is a nearly vertical slicken-sided plane, showing a shear movement of 5 feet. Apparently the southwest side moved northwestward. Between Wright and Alma, the railway track was badly bent in places (see plate 107A), but the ground did not crack noticeably. It seems to have been subjected to compression, for 7 inches had to be cut from the rails when the track was repaired. A large landslide also occurred close to Wright Station, partly damming up the stream. The fault past a little west of Wright, tearing up the public road at several places (plate 65A), especially at the blacksmith shop, near Burrell Schoolhouse. Sulfurous fumes are said to have risen from this crack for several hours. From this place the cracks run up over the ridge just west of Skyland. Large fissures show in the orchards and fields on the eastern side of the ridge, but are not so evident on the western slope. Here, instead, great landslides occurred, and redwoods were snapped off or uprooted. Thru the timbered region from Skyland to Aptos Creek, the course of the fault-trace is marked almost its entire length by a swath of felled trees, true fault fissures being found at only two places. On the northern side of Bridge Creek Canyon there are typical cracks from 1 to 8 inches wide, and here also occurred a great landslide which buried the Loma Prieta Mill. The second place where fault fractures are found is on the ridge between Bridge and Aptos Creeks, where there are well-defined fissures up to 18 inches in width, trending S. 3° E., with a downthrow of the western (upper) side of from 2 to 6 feet, and a relative movement of the east side a few inches toward the south. The cracked zone is about 50 feet wide. Great slides on both sides of Aptos Creek have almost made a valley of the canyon for fully 0.75 mile. Following across the ridges and canyons, the discontinuous line of slides and sinks in upland marshy places marks the course of the fault-line down into the lowland.

B. Offset in fence at Morrell's ranch, above tunnel at Wright station. This particular displacement was not found in tunnel. G. A. W.

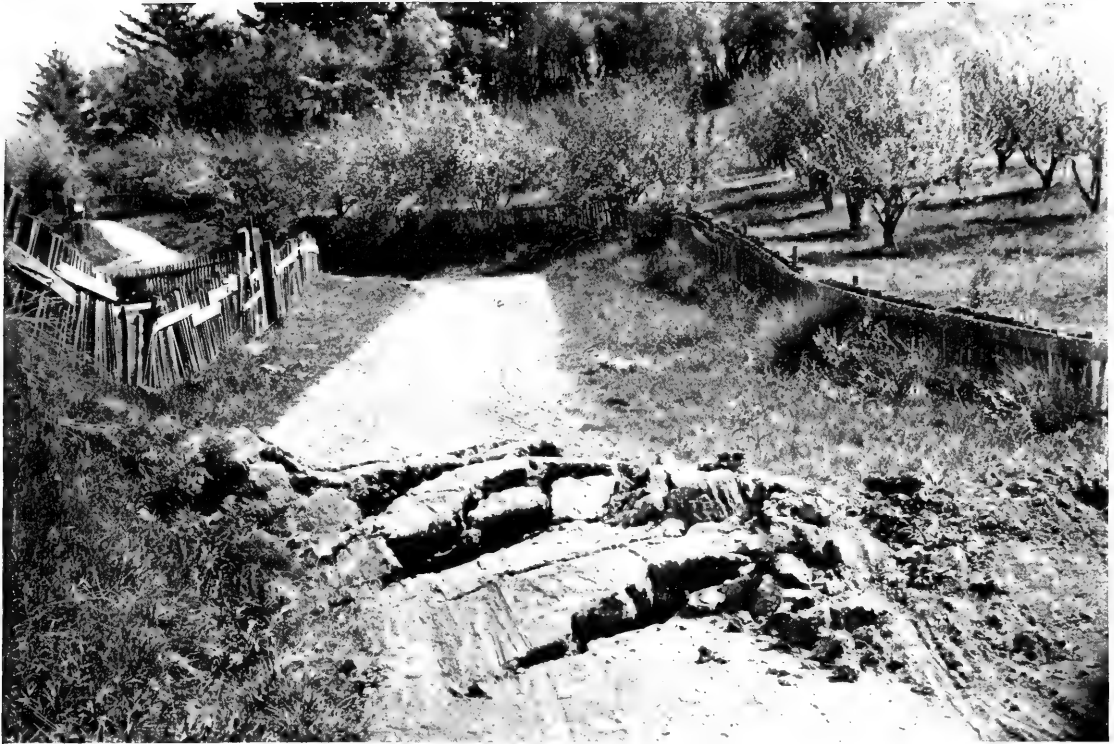
A. Offset in road near Wright. G. A. W.

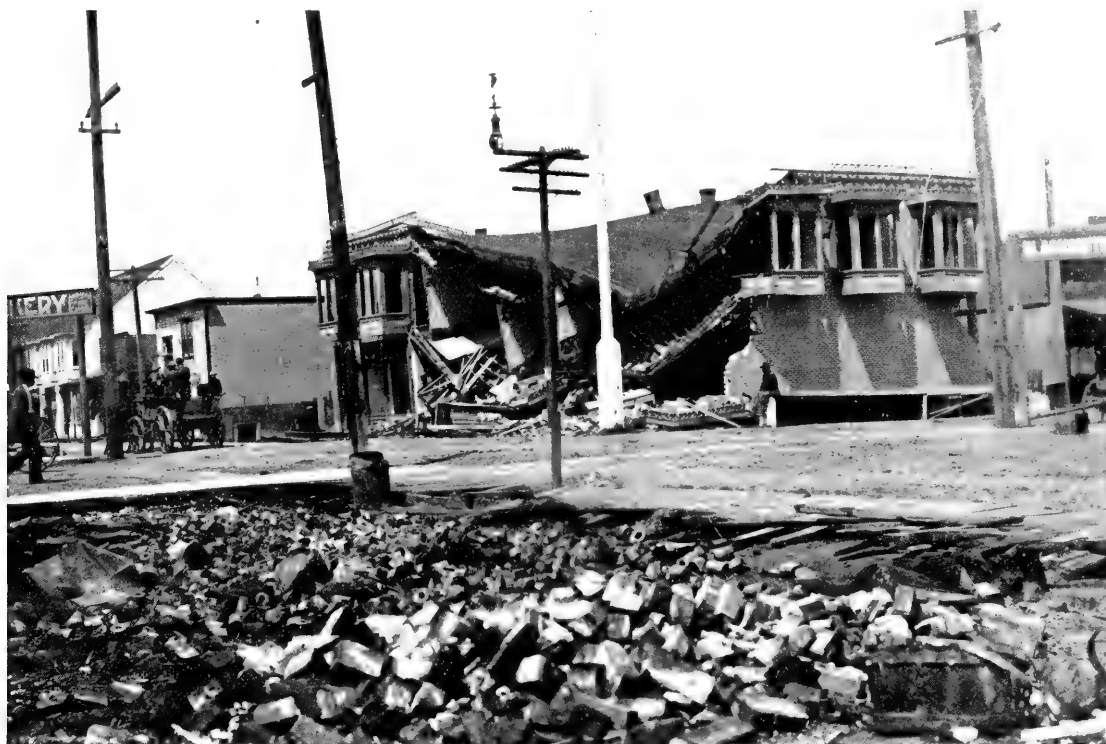
B. Wrecked buildings, Fort Bragg. Looking northwest.

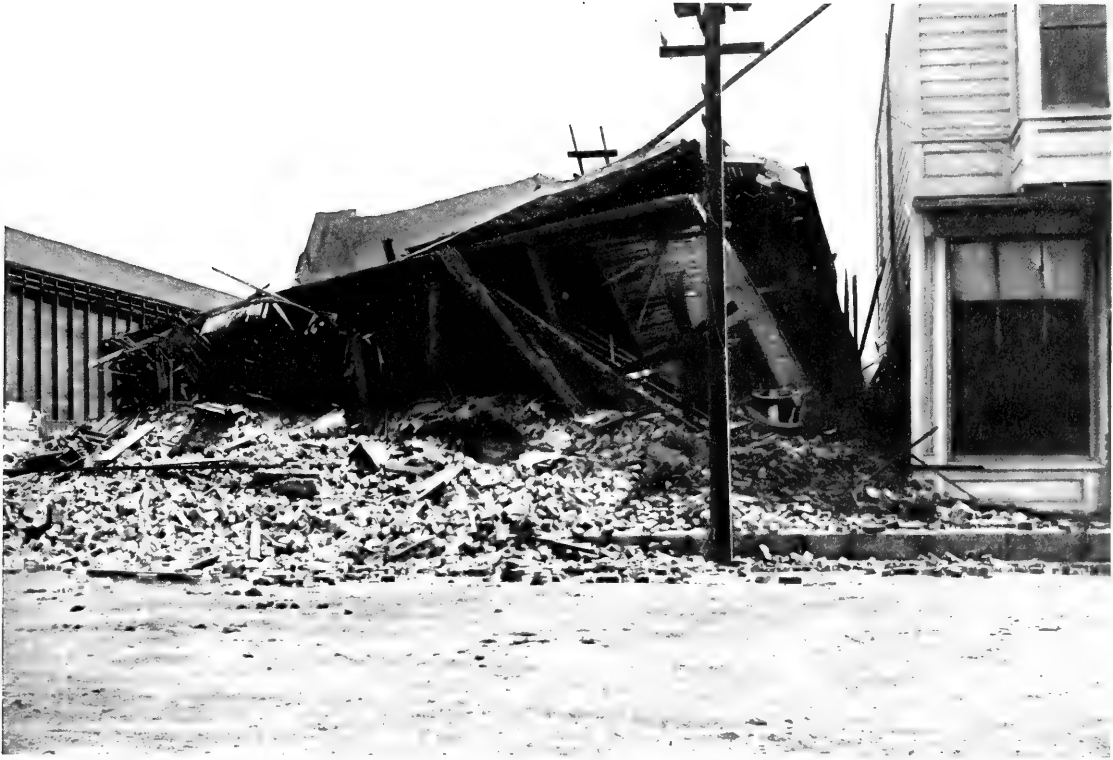
A. Odd Fellows' Hall, a 3-story brick building. Fort Bragg. Looking east.

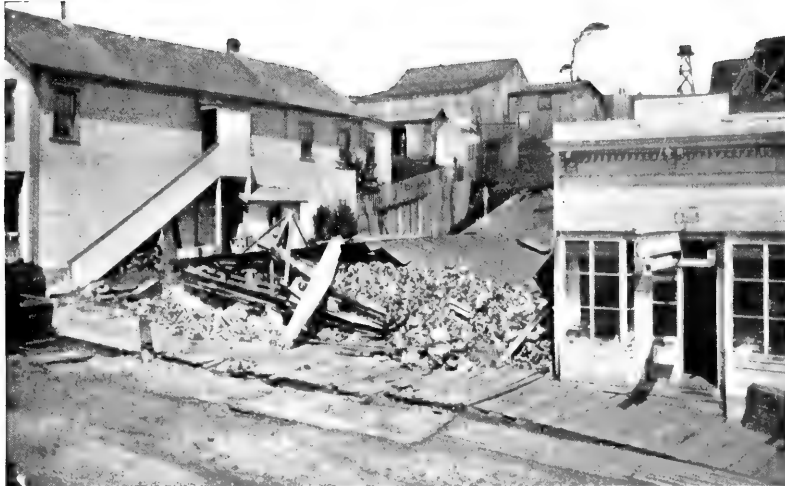
A. Point Arena. Brick house destroyed; wooden houses little affected. F. E. M.

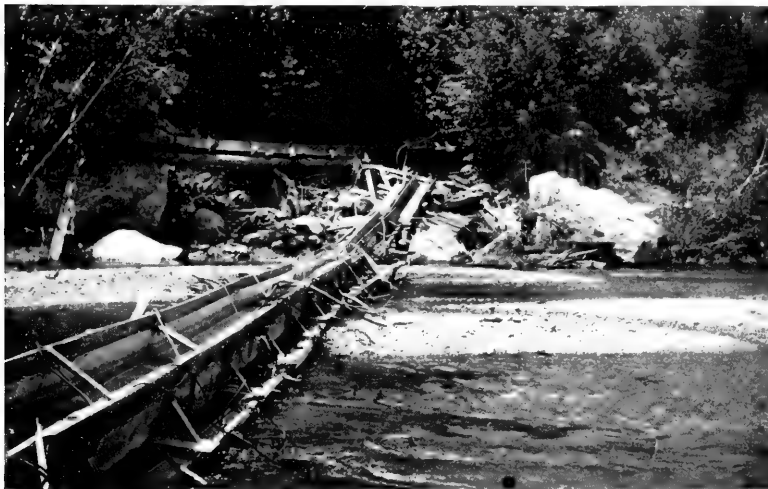
B. Wreck of suspended flume across Garcia River. Looking west. F. E. M.

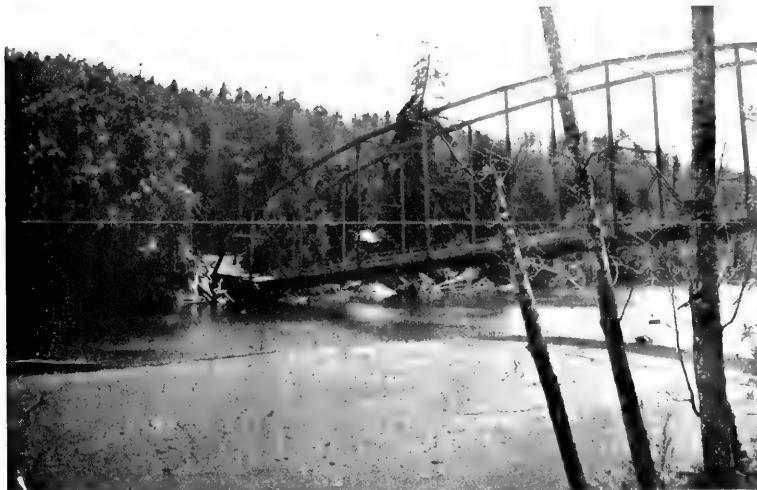
C. Collapsed wagon bridge over Gualala River. South end dropt 20 feet. F. E. M.

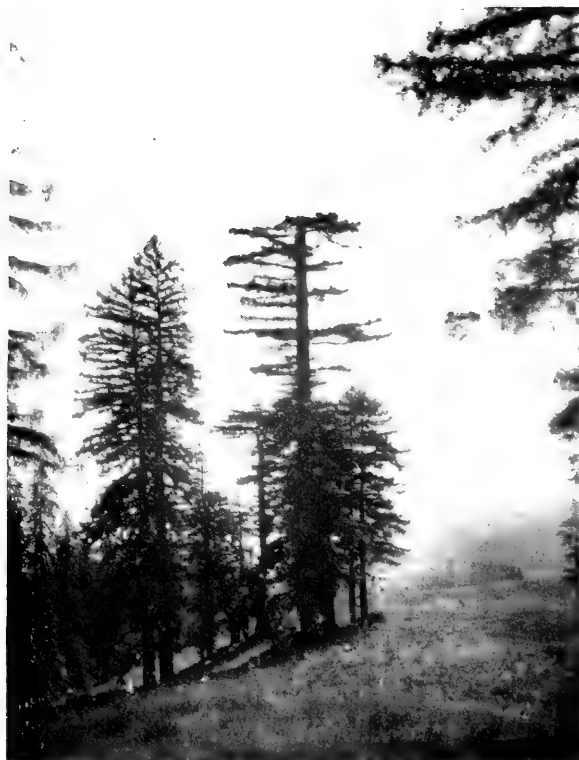
A. Sound redwood tree snapt off 42 feet from top. Near Fort Ross. F. E. M.

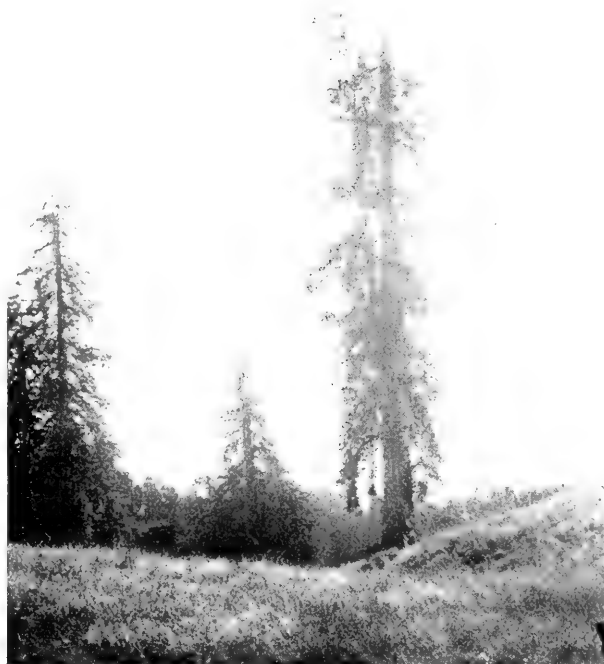
B. Redwood tree snapt off. Locality, 0.25 mile east of fault above Fort Ross. F. E. M.
